## The Writing's on the Wall

# Valuing Heritage Graffiti

## FACELIFT FOR OLD OBSERVATORY

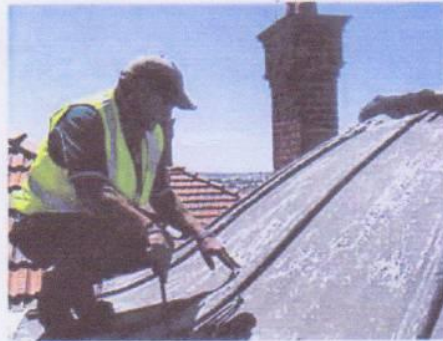
The Old Observatory's lead linings revealed some surprising scribbles and engravings in the Spring of 2009. With a little elbow grease and a metal brush the contractors working on the second highest point of the National Trust's headquarters in West Perth, discovered that previous tradesmen had had left their mark on the structure. In all, twelve separate graffiti elements including dates, names and initials dating as far back as 1932 were discovered on the projecting rounded oriel roof.

**ABOVE LEFT TO RIGHT** | Plan depicts twelve individual graffiti elements located in the lead work of the Old Perth Observatory oriel roof, as discovered by contractors during recent conservation works (second pic): G Pickering. The 'Keon Graffiti' lasted a fortnight. National Trust (VIC)

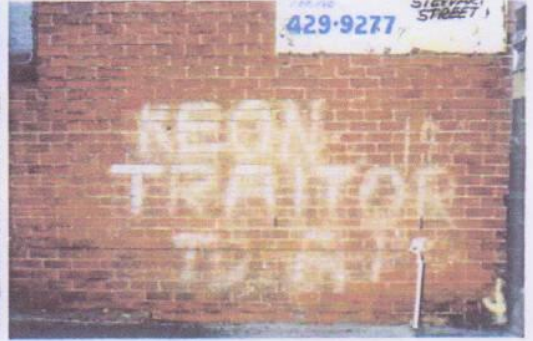
The Old Observatory in Perth gave up some of its hidden and long held graffiti secrets during recent conservation work to repair roof leaks and replace its unusual curved guttering. The discovery came within weeks of the 20th anniversary of the fall of the Berlin Wall, internationally recognised for its political heritage landmark qualities and defining graffiti markings. While both heritage sites are worlds apart, they highlight questions about the heritage value of graffiti in the cultural landscape.

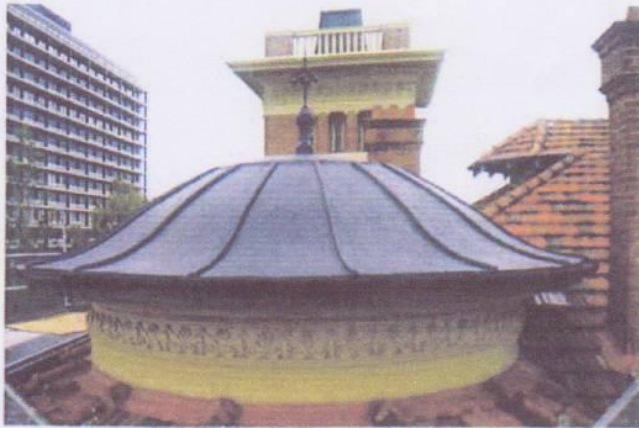
Repairs to the Old Observatory's oriel roof have been completed. G Pickering

After 103 years the lead was cracked and slipping downwards with a number of poor quality patches from past repair work. Leaks were rotting the curved cedar sarking boards beneath and damaging the ceiling below. Lead drooping into the cast iron gutters resulted in rusting and failure of the gutters.

With funding support from Lotterywest, conservation works were carried out in October 2009. One of the nineteen 950mm rounded gutter segments was taken to a foundry and used to construct a mould for casting of new gutter. Once installed the cast iron gutter looks and works exactly like the original. One original gutter segment will be stored in ceiling space for future reference.

A major aim of the work was to conserve and retain the existing lead cladding. Only the rotted sections of sarking boards were replaced and then all timbers were protected with a fungicide. Skilled tradespeople were able to rework the lead, repair cracks and replace each piece in original positions. A final sealing coat was applied and the rest of the oriel and gutters were painted. The finished conservation work is now an attractive part of the building and will be watertight for years to come.

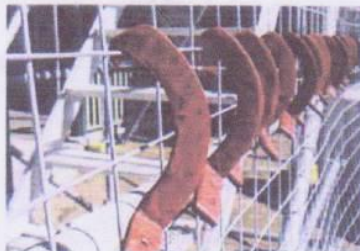
Original brackets were reinstated during works on the roof.
